RADIANT HEATING AND COOLING SYSTEMS

proPANEL®

TECHNICAL BULLETIN

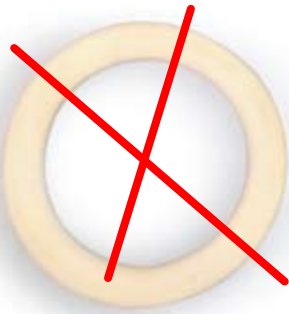
Incorrect Gasket

Correct Gasket

Find the accessory pack in the panel. If the gaskets in the accessory pack are white, they are the incorrect gaskets.

The white gaskets at the piping connections do not properly seal and will leak upon initial system test.

For Contractors: If your proPANEL has the incorrect (white) gaskets, order the Universal Replacement Gasket Kit for proPANEL 90 Series (A3509290) through Uponor's RMA process at no cost to you. To replace the gasket, simply loosen the nut on the connection joint, remove the old gasket, install the new gasket and tighten the nut.
