RADIANT HEATING AND COOLING SYSTEMS

CLIMATE CONTROL™ NETWORK SYSTEM RELAYS AND CONTROLS

TECHNICAL BULLETIN

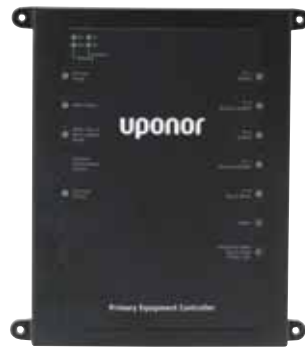
Boiler Relay, Modulating
0-10VDC (A9012020)

When connecting the relay or control to its corresponding controller, the communications to the PEC or SWT stop working and the Field Module light on the Router Main Control (RTR) changes to solid red.

Wiring a powered, third-party device to a direct-modulating output connects the power systems together. This type of connection only works if the power systems are completely isolated or if the grounding polarity of low-voltage (Class II) devices is carefully observed. If voltage is present in either of these cases, possible causes include transformer polarity, transformer grounding, bad transformers or connection to the line voltage terminals.

With both systems powered on and before making the final connection, check the AC and DC voltage from common to common and from 0-10VDC output to 0-10VDC input. There should be no (or almost no) voltage potential between these terminals in AC or DC.
