# In place in a couple of days

The waste water channel for the pulp line of the mill, which was renovated in 2017, was commissioned in the 1960s. Now there were fear that it would collapse. The new solution was Weholite.

Weholite pipes made of polypropylene met – and even surpassed – strict requirements in the renovation of a waste water channel at the Stora Enso Oulu mill in Northern Finland. Timed for a maintenance stop of nine days, the installation proceeded quickly and was finished well before the deadline.

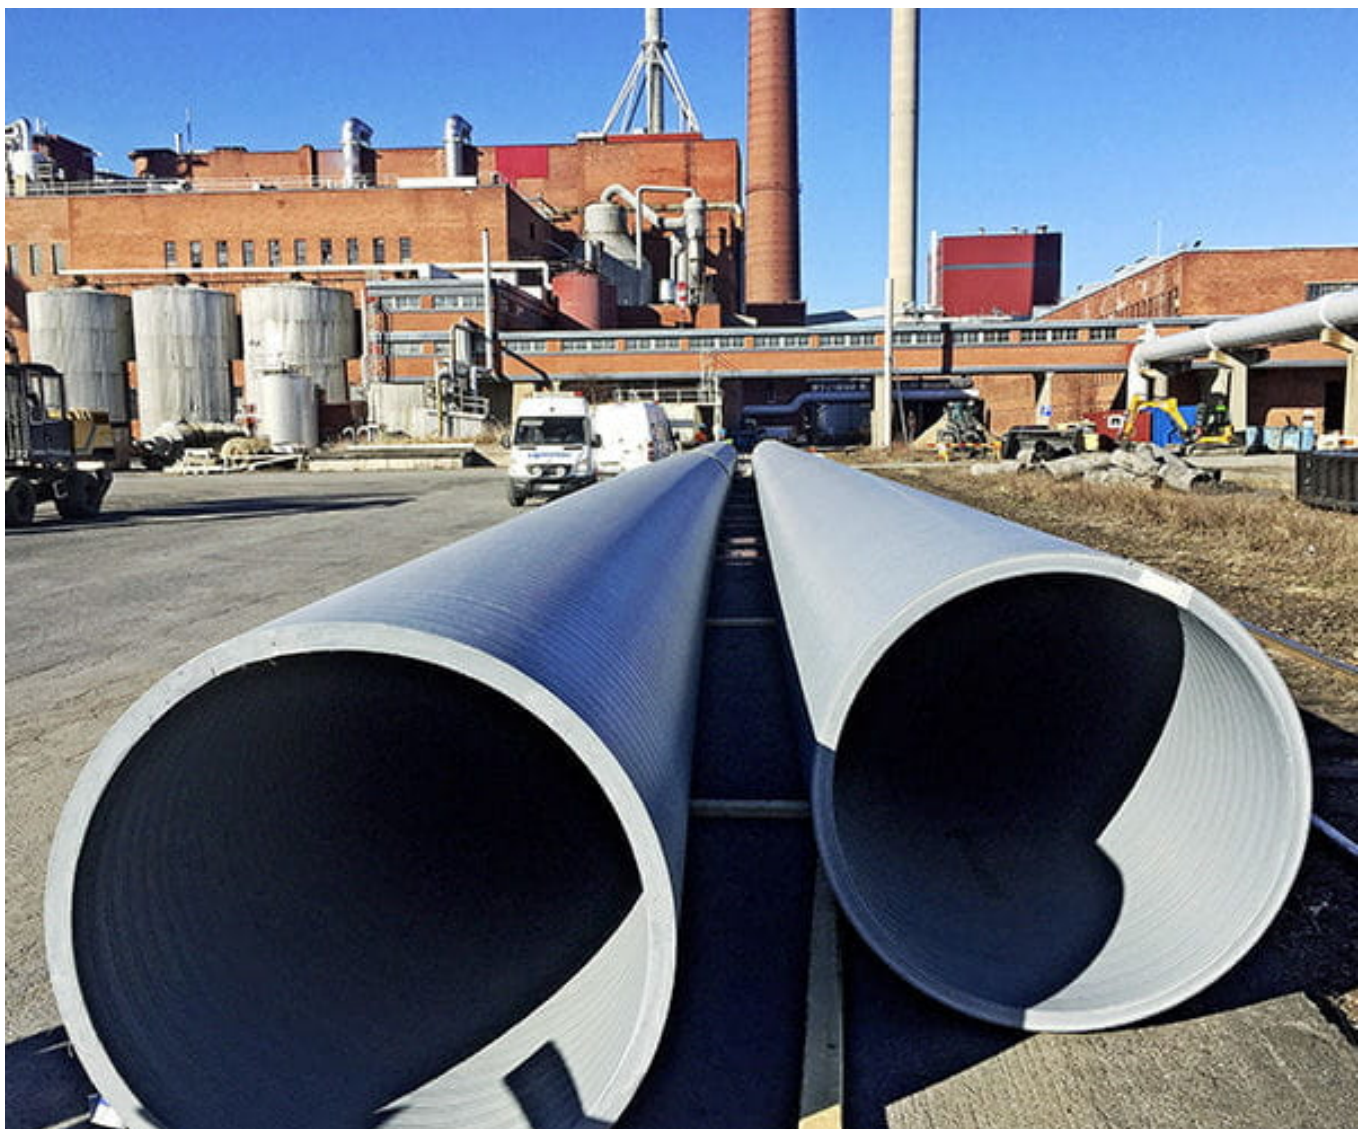
### **In place in a couple of days**
